ENGINEERING COMMITTEE MEETING AGENDA

OESTE MONITORING WELL CLUSTER
WELL CONSTRUCTION REPORT
MOJAVE WATER AGENCY
PINON HILLS, CALIFORNIA

Water Operations Manager's Report August 2023

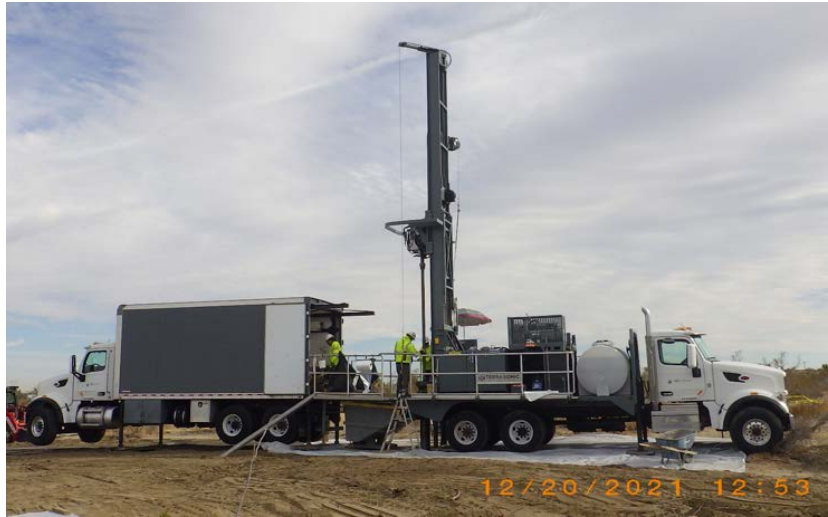
Terrasonic 600 drill rig

The borehole for monitoring well ORMWP was advanced using sonic drilling methods. Temporary steel casing was driven into the formation using a telescoping approach, with 10-inch diameter casing to 100 feet bgs, 8-inch diameter casing to 320 feet bgs, 6-inch diameter casing to 375 feet bgs, and 4-inch diameter casing to 400 feet bgs (Table 1). The sonic well borehole was drilled using a Terrasonic 600 drill rig.

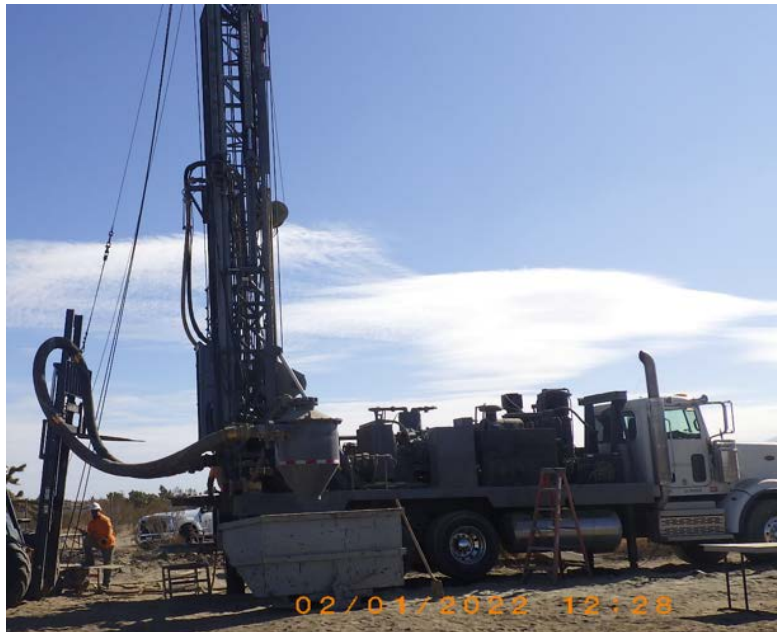
Speedstar 50K rotary drill rig configured for ARCH

The borehole for ORMW1 was advanced using the air rotary casing hammer (ARCH) drilling method. Temporary steel casing is driven into the formation using a hydraulic hammer, with a standard tricone bit of similar diameter drilling just ahead of the casing. Compressed air is used as the circulating fluid, thus no water is added during the drilling process. The temporary casing was advanced using a telescoping approach, with 11¾-inch diameter casing to 240 feet bgs and 10-inch diameter casing to the total depth of 660 feet bgs (Table 1). The ORMW1 borehole was drilled using a Speedstar 50K rotary drill rig configured for ARCH.

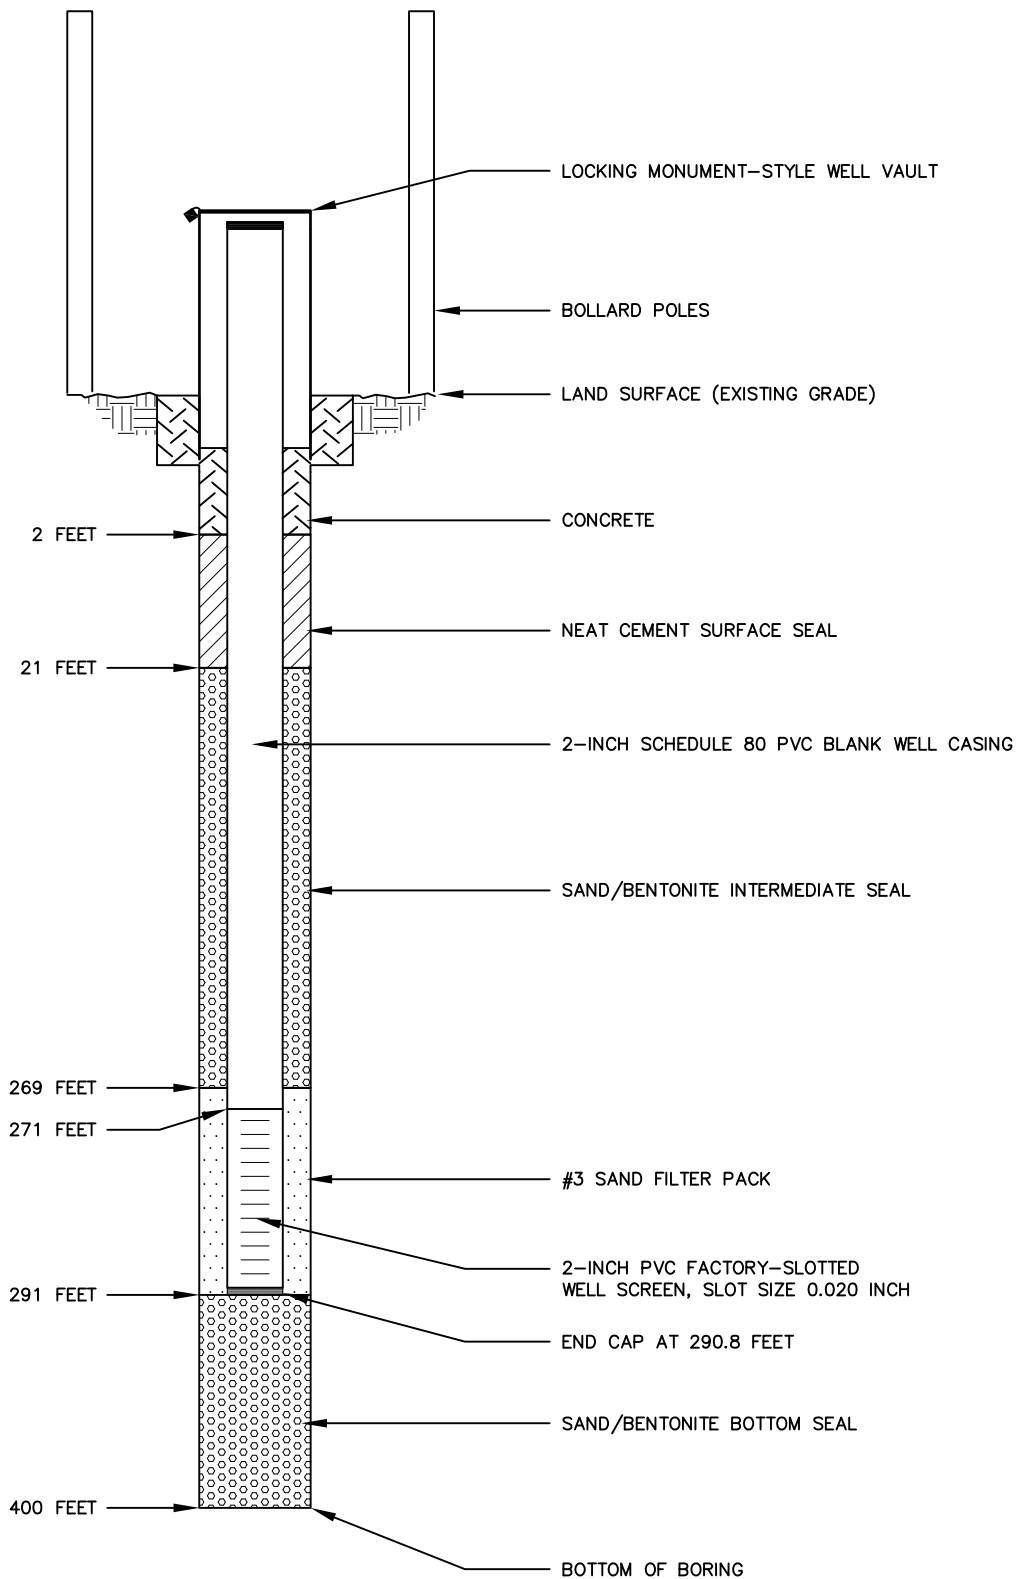
FIGURE 3.
SCHEMATIC CONSTRUCTION DIAGRAM,
MONITORING WELL ORMWP

The bottom seal (portion of the borehole below the target depth for well construction) was backfilled with 50 percent No. 8 granular bentonite / 50 percent Monterey No. 3 sand by weight. The bentonite/sand seal was emplaced by pouring materials into the dry borehole from the surface, utilizing the temporary casing as a tremie pipe. The bentonite/sand seal was emplaced into the borehole from the bottom up, withdrawing the temporary casing as the borehole was backfilled.

Nominal 2-inch diameter Schedule 80 polyvinyl chloride (PVC) well screen (0.020-inch factory slotted) and nominal 2-inch diameter Schedule 80 PVC blank well casing was used to construct the monitoring well. Centralizers were installed at the top and bottom of the screen interval and at approximate 40-foot intervals along the blank well casing.

A filter pack consisting of Monterey No. 3 sand was emplaced dry in the annulus between the well screen and the borehole wall. A filter pack transition seal (intermediate seal) consisting of 50 percent No. 8 granular bentonite / 50 percent Monterey No. 3 sand by weight was emplaced into the annulus above the filter pack using the temporary casing as a tremie pipe, as described above. The temporary casing was gradually withdrawn as the bentonite/sand level rose during emplacement. The sanitary seal consists of neat cement grout containing 5 percent bentonite emplaced from the top of the intermediate seal to 2 feet bgs. From approximately 2 feet bgs to land surface, the annulus was filled with concrete in order to set the above-ground monument vault (see Section 2.3.3).

Construction of well ORMWP was completed on January 5, 2022. ORMWP was installed in a dry borehole, and is intended to act as a monitoring well screened in soil that may become saturated above a potential perching layer during future recharge events. Well construction details for ORMWP are summarized in Table 1 and Figure 3.

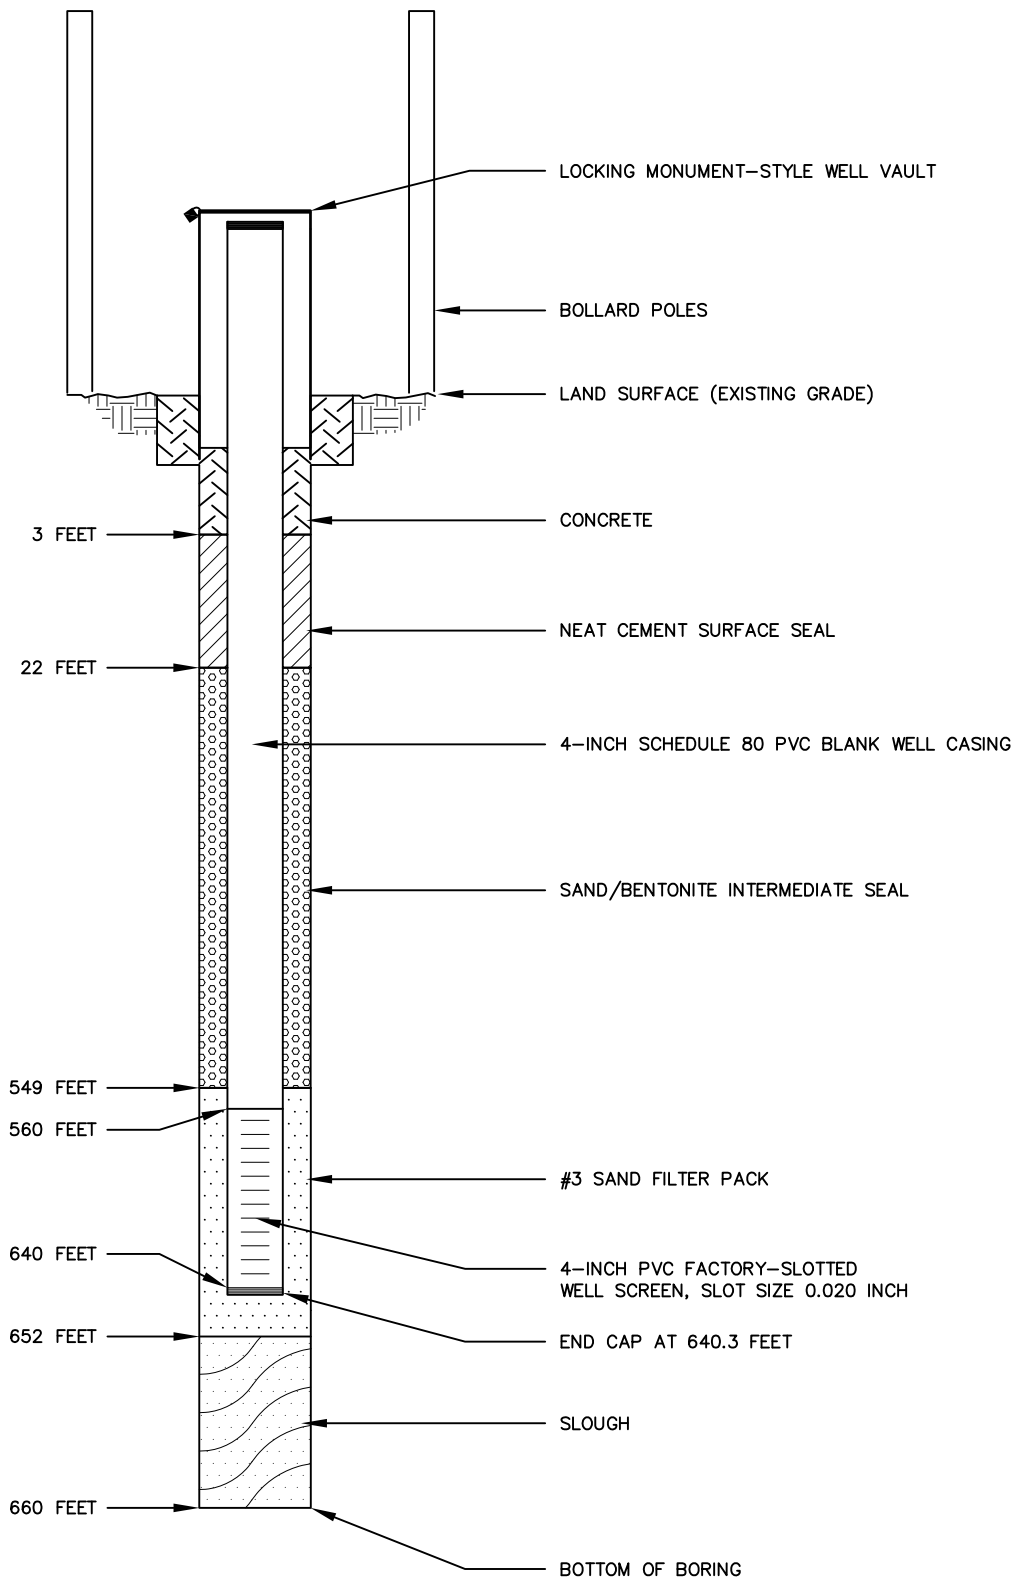
FIGURE 4.
SCHEMATIC CONSTRUCTION DIAGRAM,
MONITORING WELL ORMW1

Nominal 4-inch diameter Schedule 80 PVC well screen (0.020-inch factory slotted) and nominal 4-inch diameter Schedule 80 PVC blank well casing was used to construct the well. Centralizers were installed at the top, center and bottom of the screen interval and at approximate 40-foot intervals along the blank well casing.

A filter pack consisting of Monterey No. 3 sand was emplaced in the annulus between the well screen and the borehole wall, using the temporary casing as a tremie pipe. A filter pack transition seal (intermediate seal) consisting of 50 percent medium bentonite chips / 50 percent 8 x 16 No. 12 mesh sand by volume was emplaced into the annulus above the filter pack using the temporary casing as a tremie pipe, as described above. The temporary casing was gradually withdrawn as the bentonite/sand level rose during emplacement. The sanitary seal consists of neat cement grout containing 5 percent bentonite was emplaced from the top of the intermediate

seal to 3 feet bgs. From approximately 3 feet bgs to land surface, the annulus was filled with concrete in order to set the above-ground monument vault (Section 2.3.3).

Construction of monitoring well ORMW1 was completed on February 14, 2022. Well construction details for ORMW1 are summarized in Table 1 and Figure 4. Prior to beginning well construction activities, the bottom of the borehole was tagged at 552 feet bgs, indicating slough filled the bottom 8 feet of the borehole.

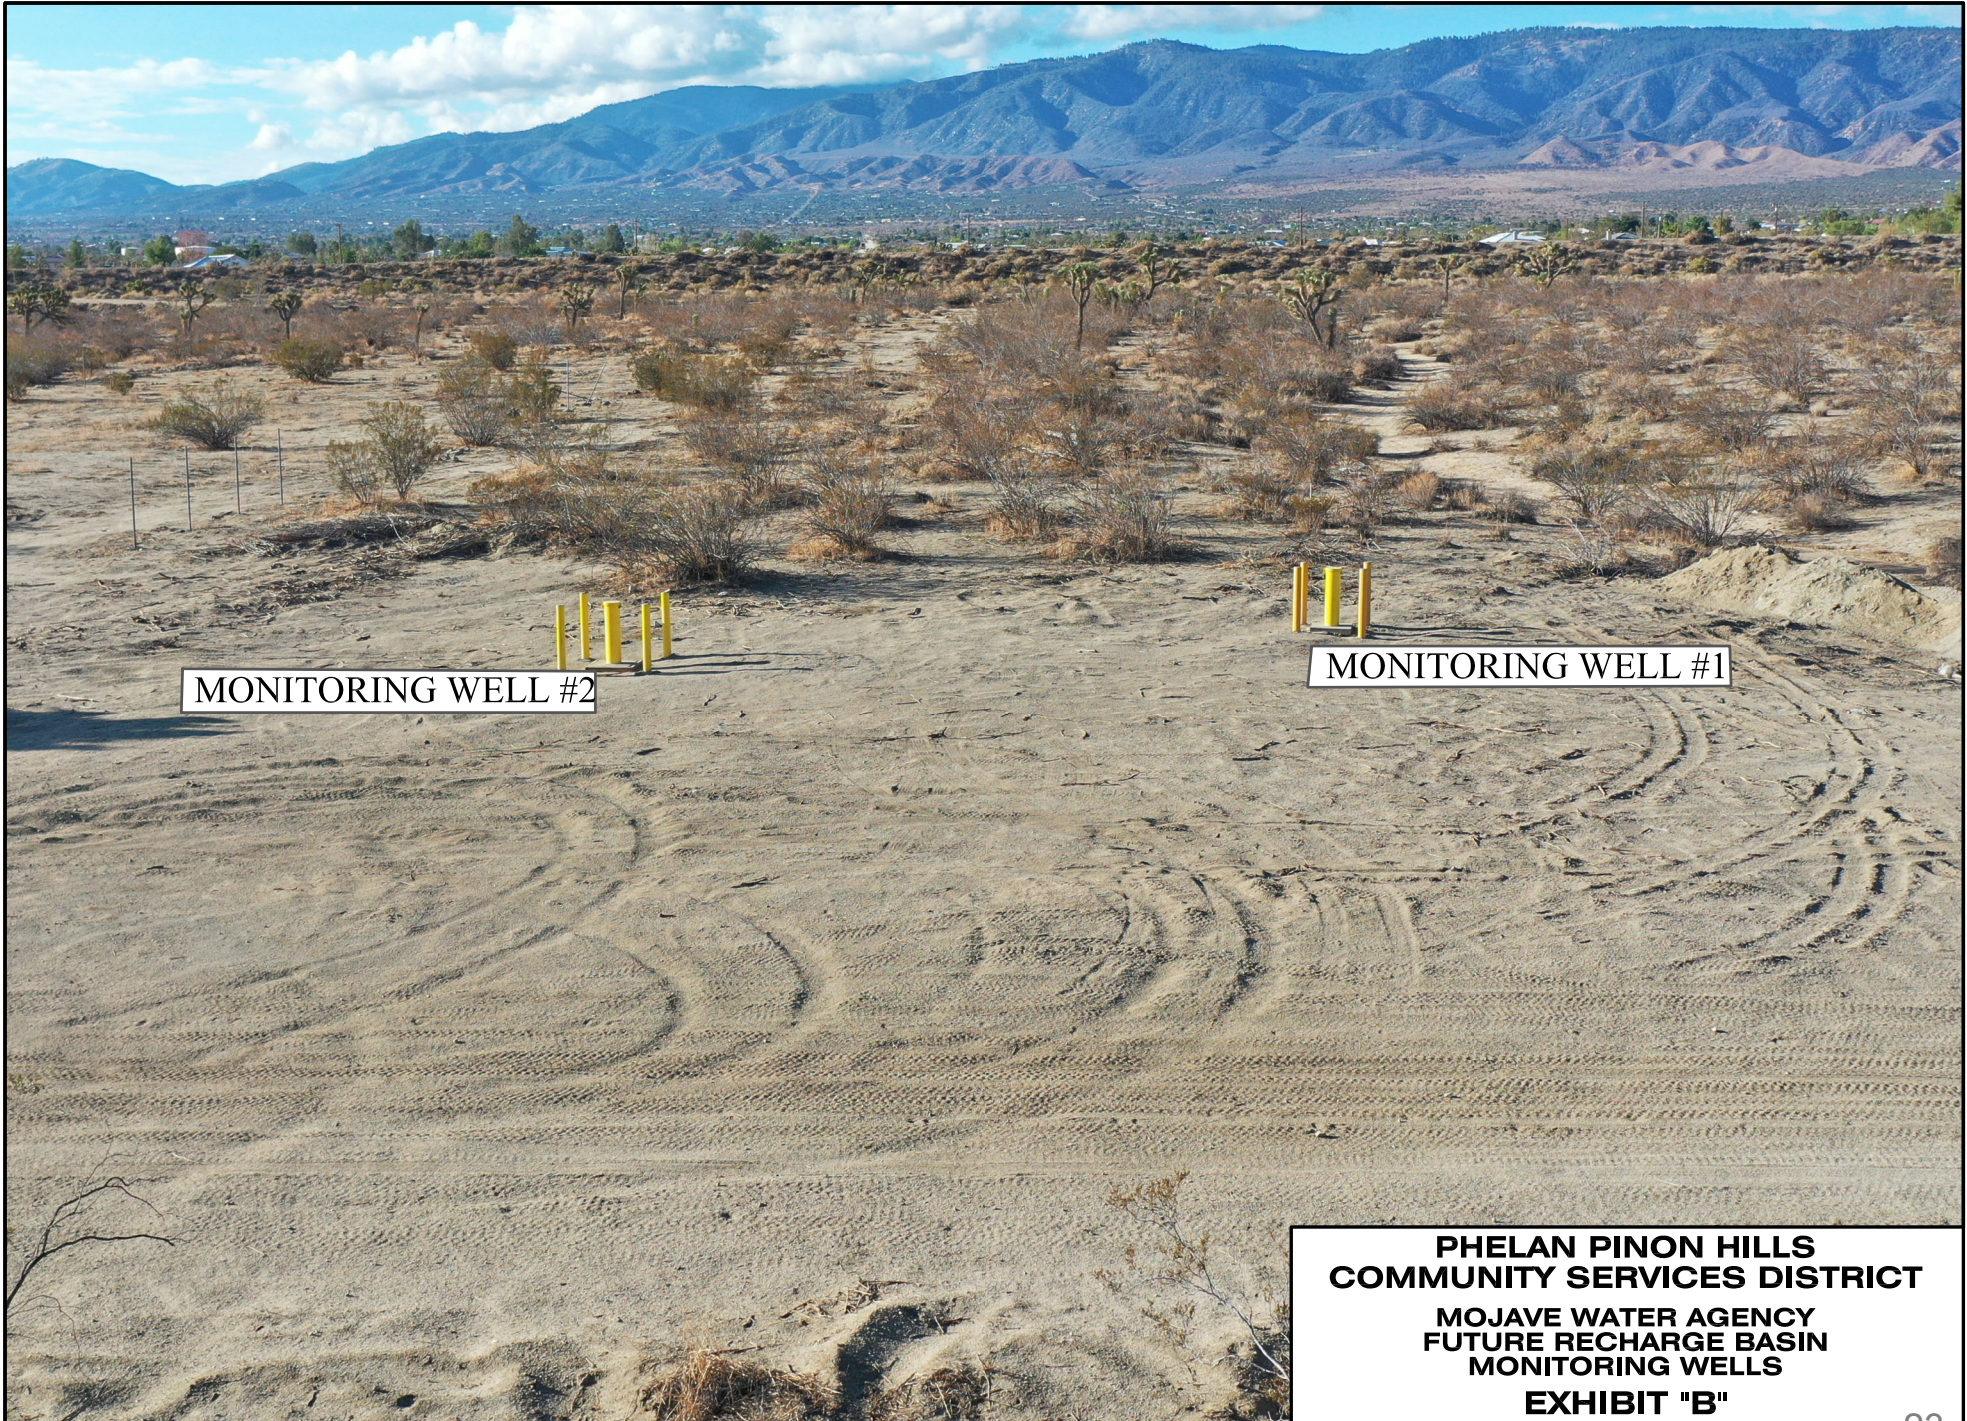
**PHELAN PINON HILLS
COMMUNITY SERVICES DISTRICT
MOJAVE WATER AGENCY
FUTURE RECHARGE BASIN
MONITORING WELLS
EXHIBIT "B"**

MONITORING WELL #2

MONITORING WELL #1
